DEPARTMENT OF TRANSPORTATION**DIVISION OF ENGINEERING SERVICES**

Contract #: 04-0120F4Cty: SF/ALA Rte: 80 PM: 13.2/13.9File #: 69.28**WELDING INSPECTION REPORT****Resident Engineer:**Pursell, Gary**Address:** 333 Burma Road**City:** Oakland, CA 94607**Report No:** WIR-000487**Date Inspected:** 04-Sep-2007**Project Name:** SAS Superstructure**OSM Arrival Time:** 2330**Prime Contractor:** American Bridge/Fluor Enterprises, a JV**OSM Departure Time:** 800**Contractor:** Zhenhua Port Machinery Company, Ltd (ZPMC), Changxing Island **Location:** Shanghai, China**CWI Name:** Lu Jian Ping & Huang Li**CWI Present:** Yes No**Inspected CWI report:** Yes No N/A**Rod Oven in Use:** Yes No N/A**Electrode to specification:** Yes No N/A**Weld Procedures Followed:** Yes No N/A**Qualified Welders:** Yes No N/A**Verified Joint Fit-up:** Yes No N/A**Approved Drawings:** Yes No N/A**Approved WPS:** Yes No N/A**Delayed / Cancelled:** Yes No N/A**Bridge No:** 34-0006**Component:** Caltrans Mock-Up**Summary of Items Observed:**

Caltrans Quality Assurance (QA) Inspector, Mike Hasler was present to observe the fitup, welding and related activities associated with the fabricating of Caltrans Mock-up, 77.0

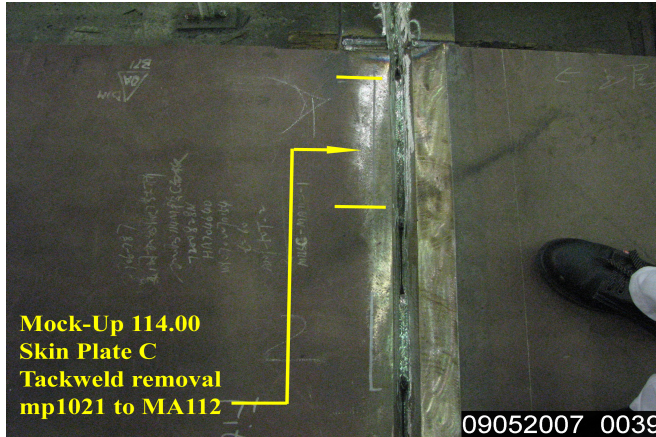
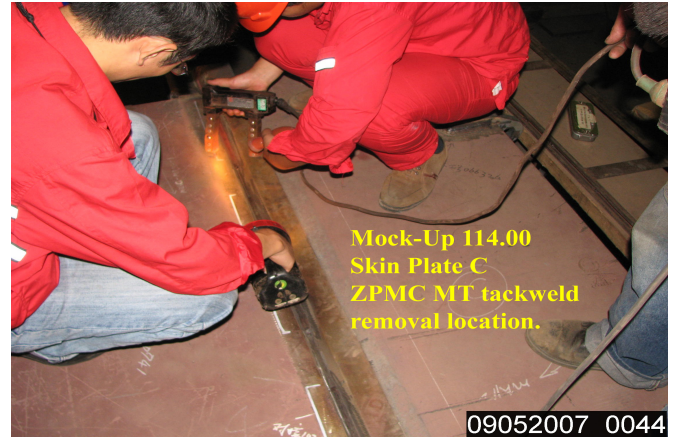
diameter 4.8 mm (.189 inches) electrode and, JF-B Flux, classification F7A2. Before welding the root weld pass at piecemark mp1021 to MA112 ZPMC observed a crack tackweld during the magnetic particle testing of the tackwelds. ZPMC elected to remove the tackweld by grinding and weld as is. Caltrans witnessed the removal of the tackweld and magnetic particle testing of the weld removal area and, no relevant indications were observed. Following digital pictures illustrate cracked tackweld location and ZPMC magnetic particle test.

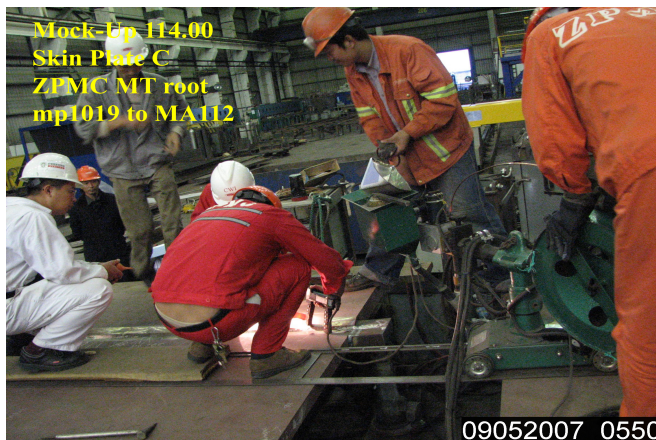
3 Skin Plate C (top) NA NA ZPMC MT testing

Caltrans QA Inspector witnessed ZPMC QC nondestructive testing (NDT) technician, Mr. Zhou Dong Yun perform magnetic particle test (MT) and Visual Test (VT), at Mock-up 114M, Skin Plate C. The testing was performed at the plate splice welds, mp1019 to MA112, weld number MUSC-MA112-4, mp1021 to MA112, weld number MUSC-MA112-2 root pass weld, inside side, one-hundred percent VT and MT coverage. ZPMC QC, nondestructive technician, Mr. Zhou Dong Yun observed scattered porosity in both welds. ZPMC elected to do some investigative grinding on the root pass weld. The scattered porosity was evaluated in accordance with, AWS D1.5-2002, section 6, paragraph 6.26.2.3 and found to be in compliance with the code acceptance criteria. Following digital picture illustrates MT in progress.

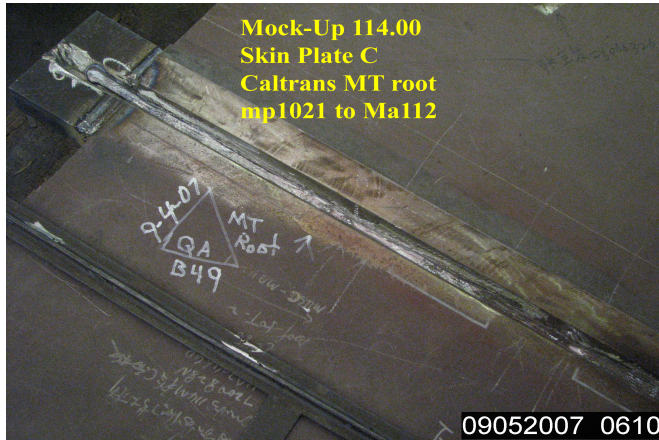
4 Skin Plate C (top) NA NA Caltrans QA MT Test

The Caltrans QA Inspector performed visual test (VT) and MT examinations at Mock-up 114M, Skin Plate C. The testing was performed at plate mp1019 to MA112, weld number MUSC-MA-112-4 and mp1021 to MA112, weld number MUSC-MA112-2 root pass weld, inside side, one-hundred percent VT and MT coverage. Following digital picture illustrates Caltrans QA, distinguishing inspection symbol, noting the MT testing has been performed on the root weld pass. See Caltrans Magnetic Particle Test Report, TL6028, generated on this date for additional information.
